Case Presentation

*Diagnostic Imaging Service, Osteoarticular/Musculoskeletal Area - Interventionism, Sanatorio Allende, Córdoba, Argentina **Orthopedics and Traumatology Service, Sanatorio Allende, Córdoba, Argentina

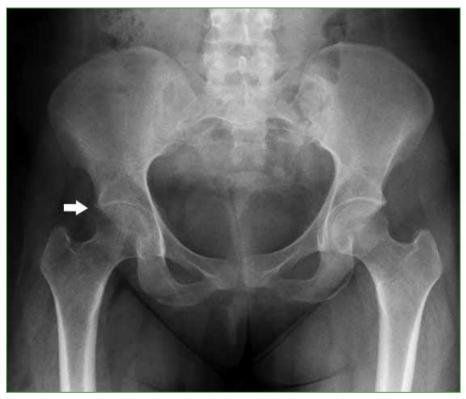
Figure 1. Panoramic pelvic radiograph. Incipient arthritic changes with acetabular overcoverage are observed (arrow).

Panoramic radiographs of the pelvis and right hip showed incipient arthritic changes with minimal acetabular overcoverage. No lytic or blastic lesions were visible.

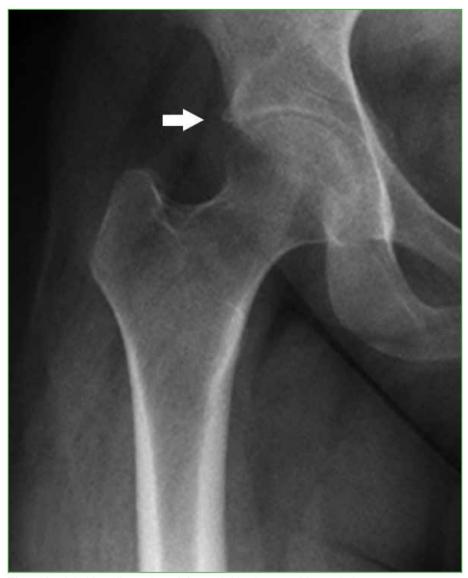
Figure 2. Right hip radiograph. Incipient arthritic changes with acetabular overcoverage are visualized. No soft tissue lesions are observed.
