Posterior dislocation of a hinged knee prosthesis

Case report

*Orthopedic Surgery Service, Hospital Británico of Buenos Aires,
Ciudad Autónoma de Buenos Aires*

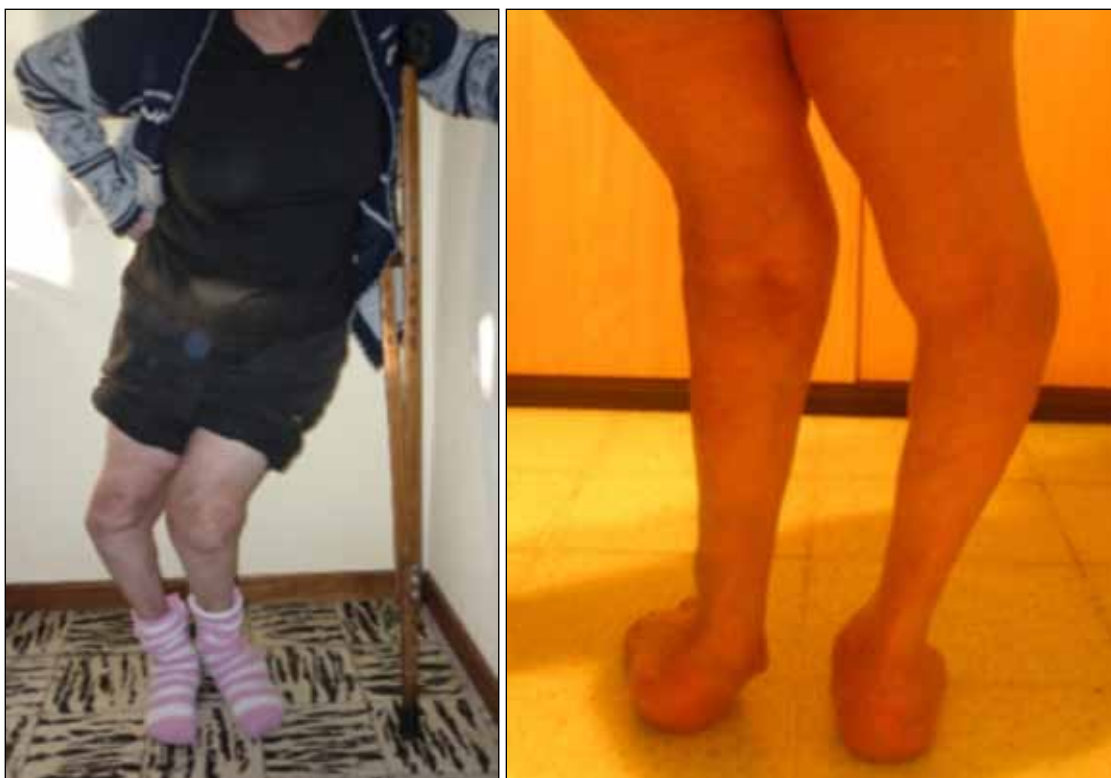
▲ **Figure 1.** Bilateral knee deformity with varus misalignment in right knee and valgus misalignment in left knee, both with multidirectional ligament instability.

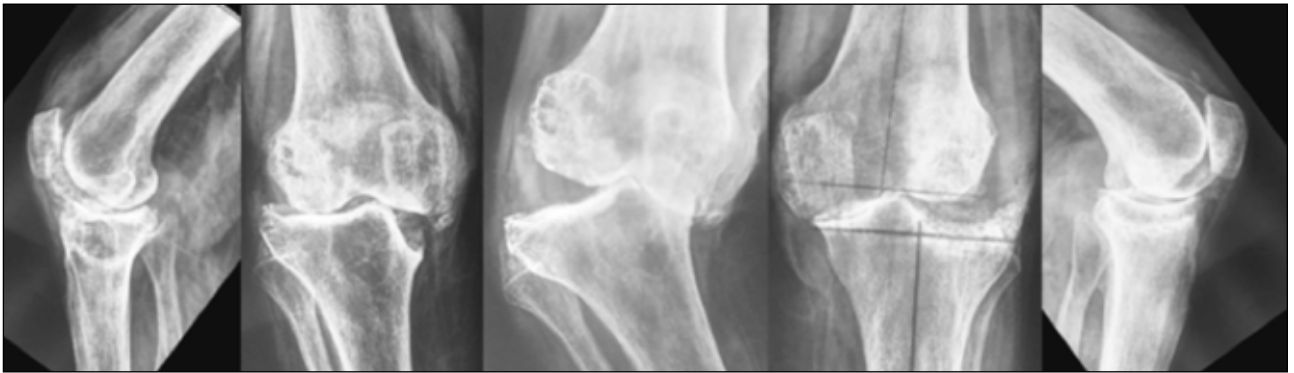
▲ **Figure 2.** X-rays showing right varus-knee osteoarthritis with extensive bone defect in the medial tibial plateau and left valgus-knee osteoarthritis, also associated with extensive bone defect in lateral tibial plateau.

Sixty-nine-year old female with 13-year rheumatoid osteoarthritis-history treated with high-dose methylprednisone and methotrexate during 12 years that consults for 5-year history bilateral-knee pain which limits walking at home and requires two-crutch assistance. At physical examination, we detect bilateral knee deformity with varus misalignment in right knee and valgus misalignment in left knee, both with multi-directional ligament instability (Figure 1). In X-rays we verify right varus-knee osteoarthritis with extensive bone defect in medial tibial plateau, and left valgus-knee osteoarthritis also associated with extensive bone defect (Figure 2).

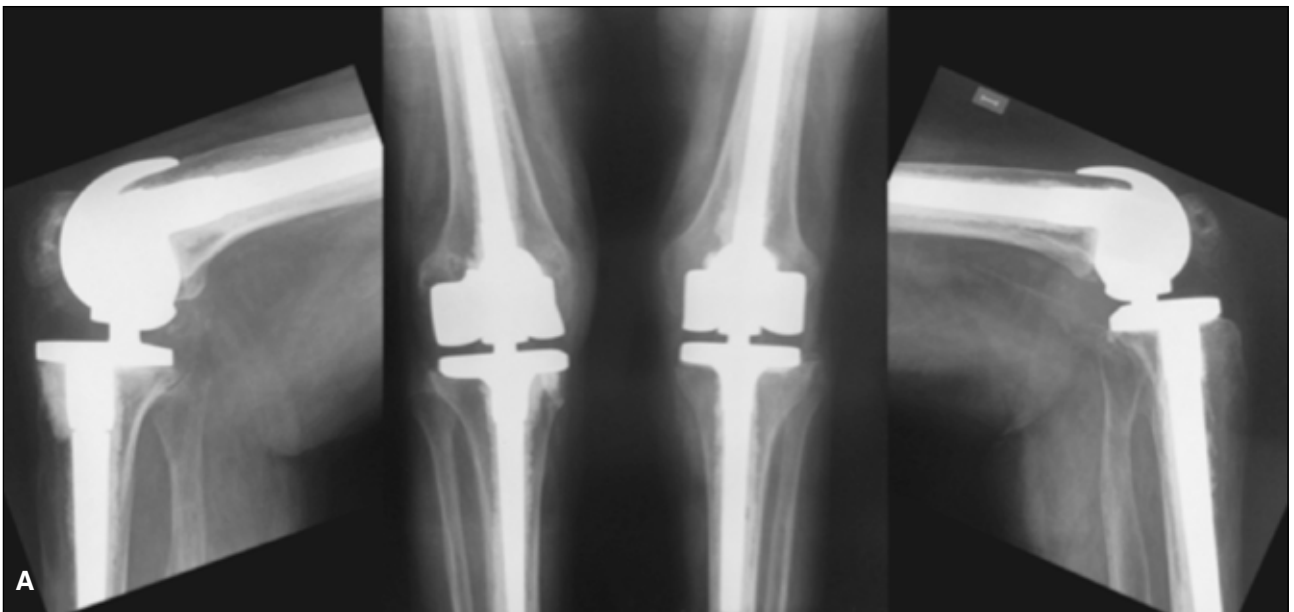
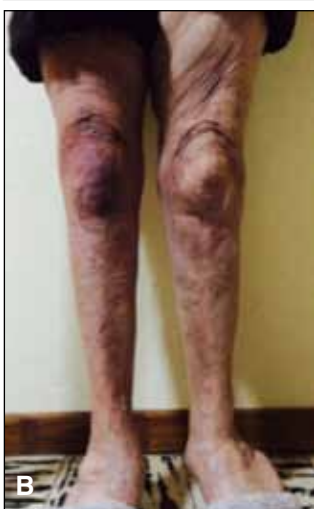
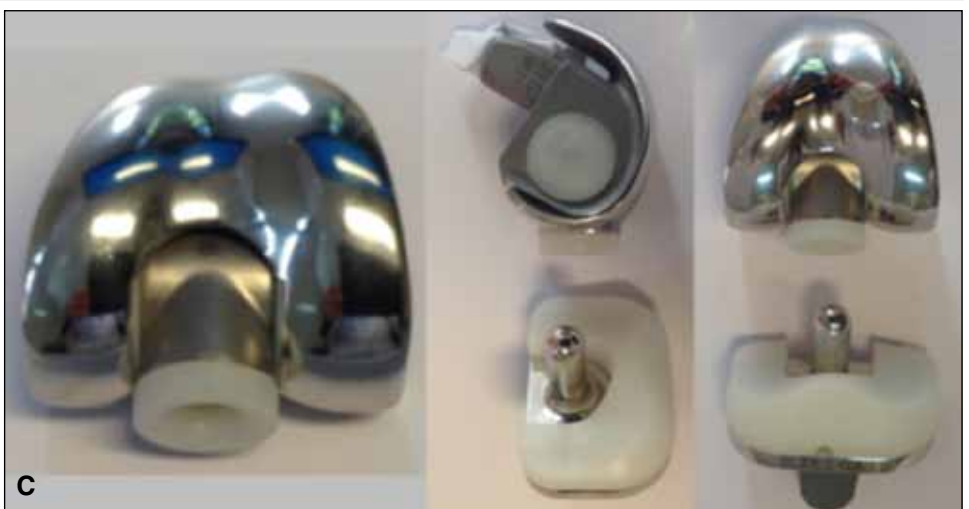
▲ **Figure 3.** A. Postoperative X-rays. B. Medical outcomes. C. Pictures of the implants we used: third-generation rotary hinged knee prosthesis (Rotax, FII SA®, Saint Just Malmont, France).

First we carried out right total knee replacement (TKR) in August 2011 and, 9 months later, left TKR. In both cases we used third-generation rotary hinged knee pro-

thesis (Rotax, FII SA®, Saint Just Malmont, France). Two and a half years after right TKR, the patient consults for acute pain and functional impairment in right knee secondary to mechanism of extreme knee flexion while going from sitting position on a low seat to a two-feet-standing position. At physical examination, we verify a painful knee, with active 5-100° active flexion-extension and instability in both coronal and sagittal planes. In X-rays we verify signs relatable to knee prosthetic dislocation with neither loosening signs, nor polyethylene wear evidence, nor components fatigue (Figure 4). We tried closed reduction under anesthesia, with no satisfactory results; therefore, we carried out TKR revision verifying rupture of the polyethylene axle casing in the femoral component of the hinge (Figure 5). Due to the patient's low demand, we went on with open reduction with no prosthetic change.

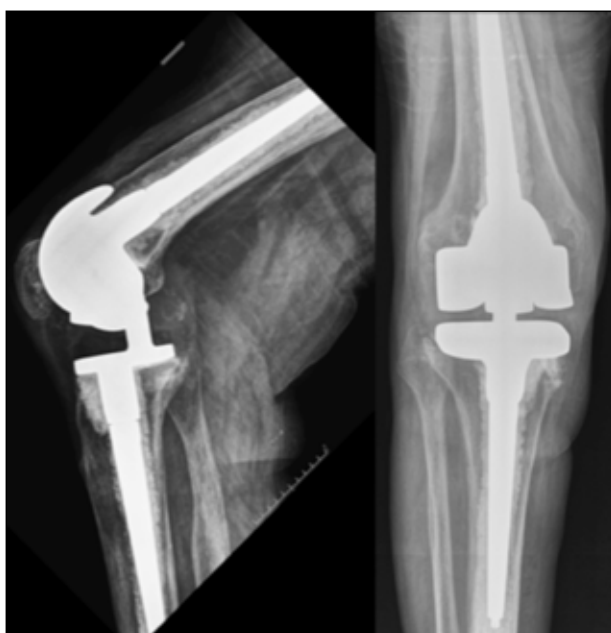
▲ **Figure 4.** X-rays showing posterior knee prosthetic dislocation.

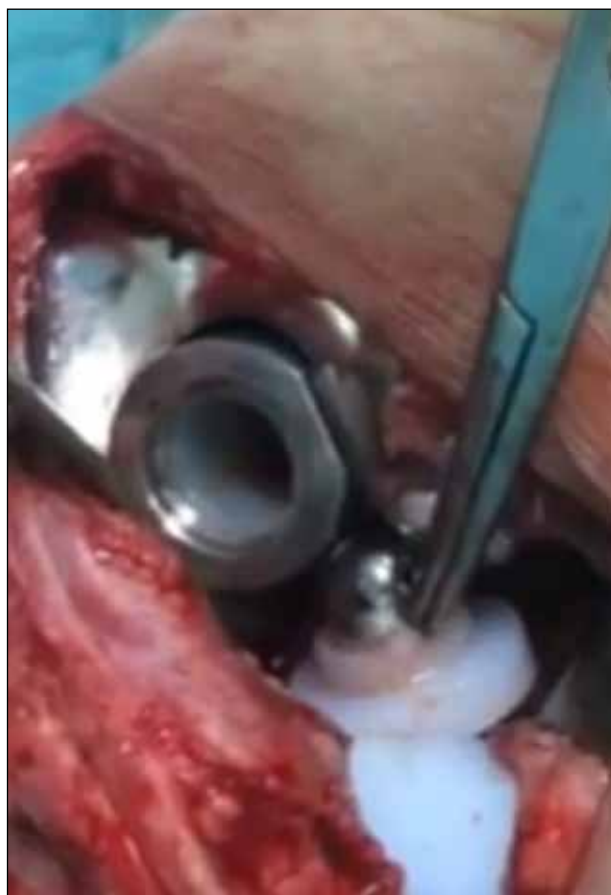
▲ **Figure 5.** Intrasurgical picture showing the rupture of the polyethylene axle casing of the femoral component of the hinge.

In some knee prostheses such as the Rotax knee prosthesis, which was the one we used in our patient, the assembly device between both components allows surgeons to carry out distraction during knee flexion and extension, which is limited by the soft tissues tension with no capture mechanism whatsoever.¹ In our case, at first the complication was interpreted as a dislocation due to distraction tibiofemoral uncoupling in a patient with rheumatoid osteoarthritis treated with corticoids with poor soft tissues status. However, upon carrying out surgical exploration, we verified the rupture of the polyethylene axle casing,

what favored distraction dislocation because it reduced the effective working surface between the metallic post and the polyethylene axle casing. Since she was a hardly demanding patient, we opted for carrying out only reduction, verifying stability up to 90°-knee flexion. At a new instability episode, we suggested to carry out revision with replacement of the broken polyethylene component. Satisfied as she was, in spite of the aforementioned complications the patient refused the surgery. Nowadays, 18 months later, she walks at home with walker and knee immobilizer.

We agree with the bibliography we analyzed that the explanation for these ruptures is that the resistance of the polyethylene axle casing is much lower than that of its metallic counterpart. Therefore, revision is advised only when it causes evident knee disorders such as dislocation or persistent instability.¹⁰
