Behavior of Hydroxyapatite-Coated Cementless Stems Placed With Coronal Malalignment in Primary Hip Arthroplasty. Long-Term Follow-Up Results

Harold Simesen de Bielke,* Leonel Pérez Alamino,** Germán Garabano,** César Á. Pesciallo,** Hernán del Sel,** Fernando A. Lopreite**

How to cite this article: Simesen de Bielke H, Pérez Alamino L, Garabano G, Pesciallo CA, del Sel H, Lopreite FA. Behavior of Hydroxyapatite-Coated Cementless Stems Placed With Coronal Malalignment in Primary Hip Arthroplasty. Long-Term Follow-Up Results. *Rev Asoc Argent Ortop Traumatol* 2021;86(4):455-462. <https://doi.org/10.15417/issn.1852-7434.2021.86.4.1321>

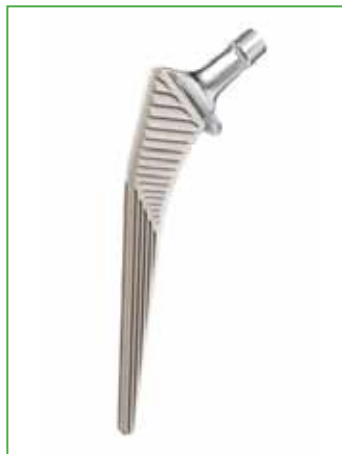
Figure 1. Corail® stem (cementless fixation). Titanium core with full Hydroxyapatite coating. Model without calcar support.

According to a retrospective analysis of the database of our Service, 681 primary THAs were performed between 2006 and 2009. In 255 (37.4%) THAs, a cementless femoral component was used; 220 (32.3%) cases corresponded exclusively to fully hydroxyapatite-coated stems (Corail, Depuy Synthes, Warsaw, Ind., USA) (Figure 1).

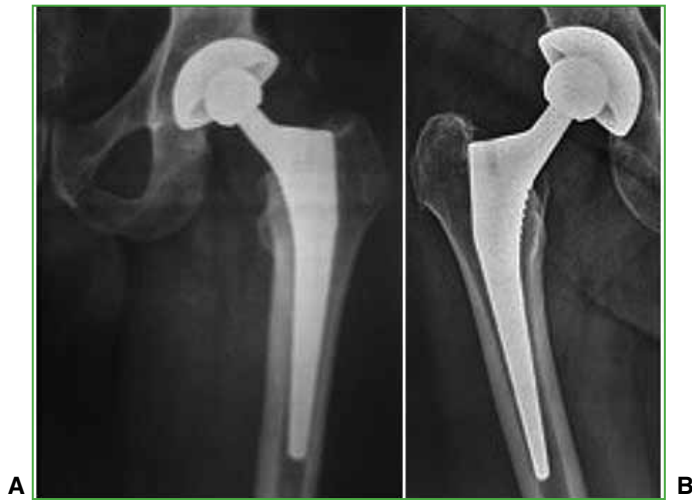
Figure 2. **A:** Anteroposterior image of left THA, 11.5 years of evolution with a varus-aligned stem. Osteolysis is observed at the level of the greater trochanter. **B:** Anteroposterior image of right THA 11.9 years after surgery, showing osteolysis at the calcar level.

Proximal femoral osteolysis was observed in two patients (3.0%): a stem with a 2° varus in the greater trochanter, with a follow-up of 11.5 years, and another hip with a 3° varus in the calcar, with 10.9 years of evolution ([Figure 2](#)). In both, there were no subsequent complications or evidence of radiographic progression.

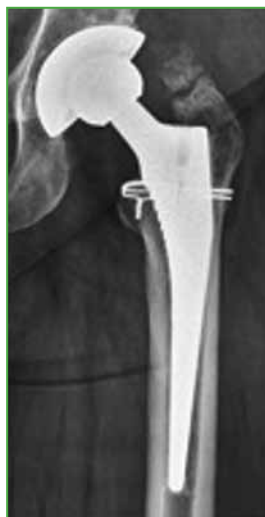
Figure 3. Postoperative follow-up after 10 years and 4 months of evolution of left THA. Intra-operative fracture treated with a wire loop. Stem with 2° valgus malalignment. A fragment of the greater trochanter can also be seen.

Two (3%) periprosthetic femoral fractures occurred. When implanting a definitive femoral component with 2° valgus, a solution of continuity was generated in the calcar that required its extraction, fixation with a double wire loop, and reimplantation of the stem (Figure 3).

The patient evolved favorably, with good function and radiographic signs of stem stability, without subsidence at 10 years and 4 months of follow-up. The other case (3° valgus) was an untreated greater trochanteric fracture; the patient had a good clinical and radiographic evolution, despite having developed a nonunion.
